SGI TESTING SERVICES

Subject: Laboratory Test Results Transmittal
Connection Strength Testing
SRW Geogrids Connected to V-Interlock Precast Blocks

SCHEMATIC DIAGRAM AND TEST PHOTOS

CONNECTION TEST RESULTS

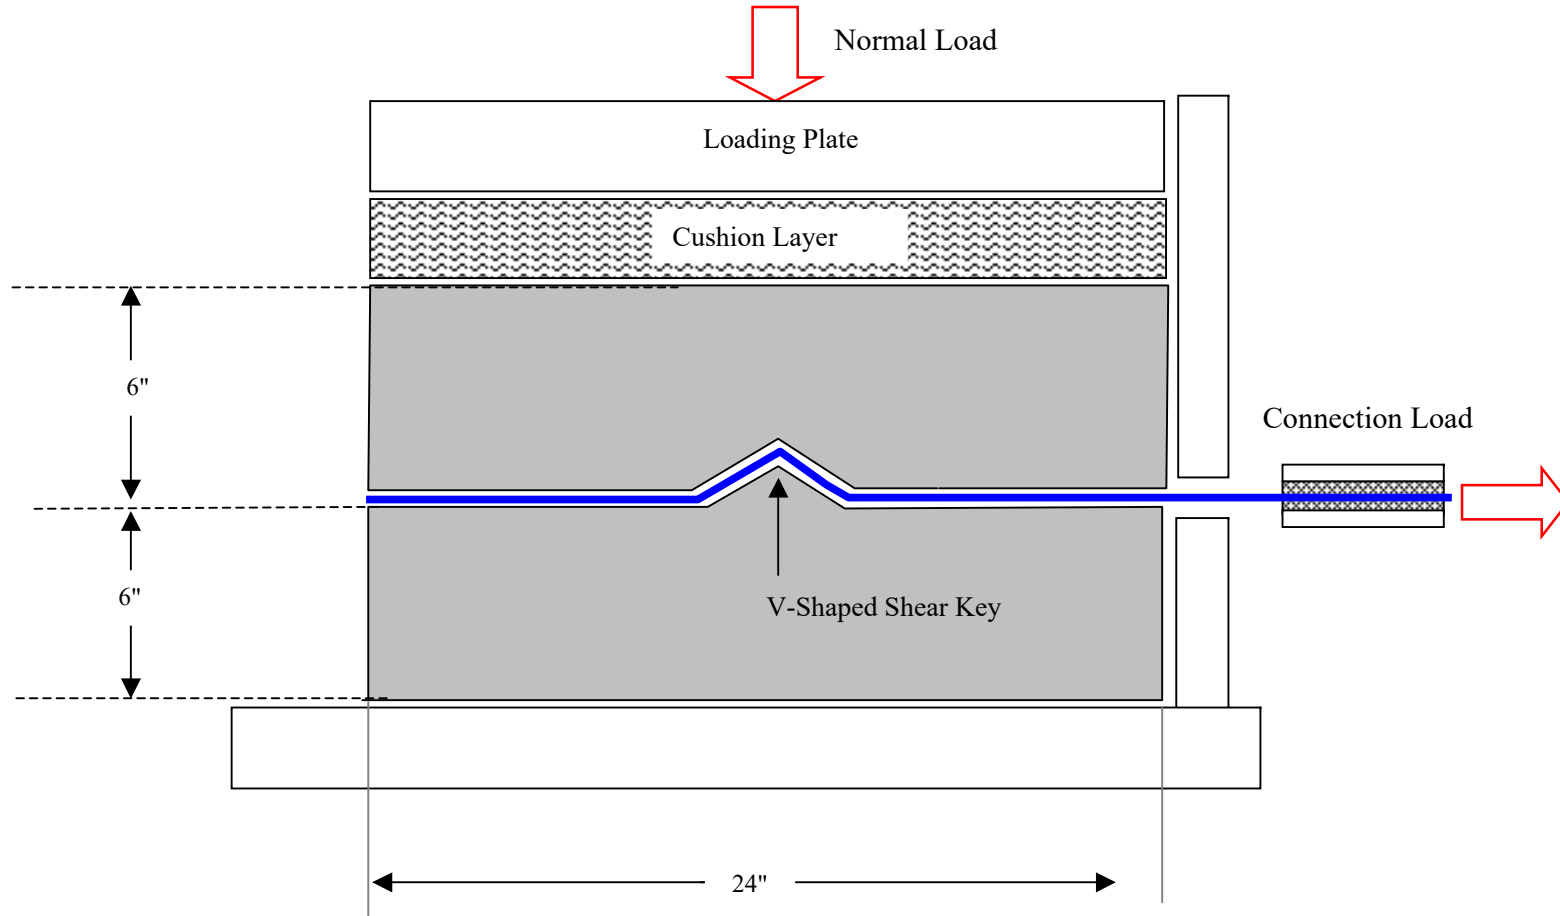
FIGURE NO. A-1

**SCHEMATIC DIAGRAM OF CONNECTION TEST CROSS-SECTION
V-INTERLOCK PRECAST BLOCK**

(NOTE: Not to Scale)

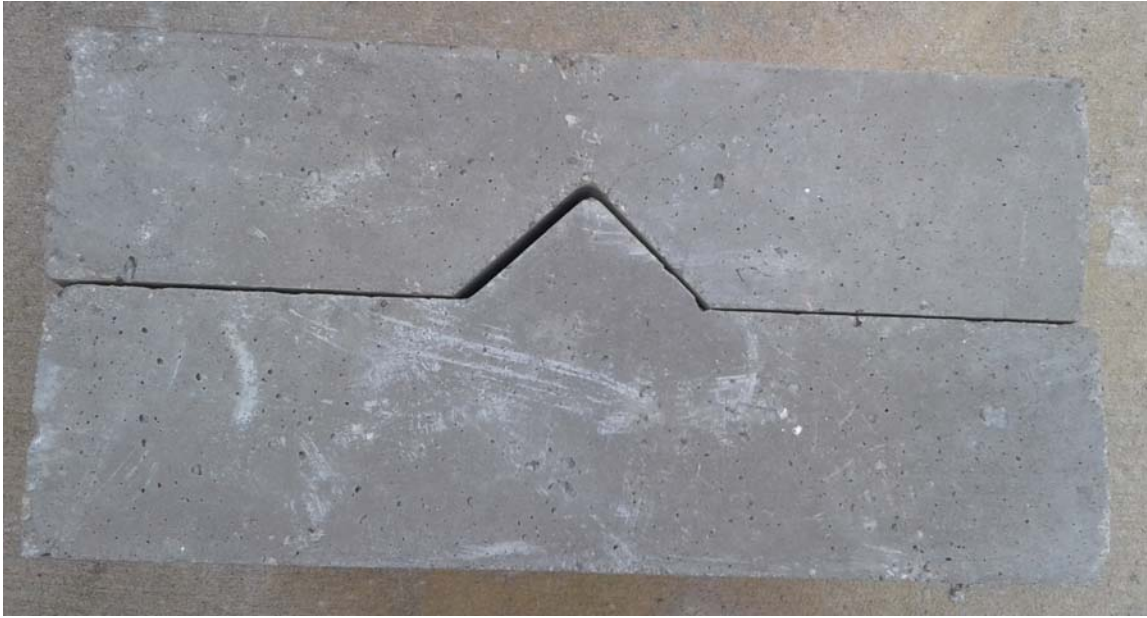
Figure A-2. Side view of top and bottom V-Interlock blocks.

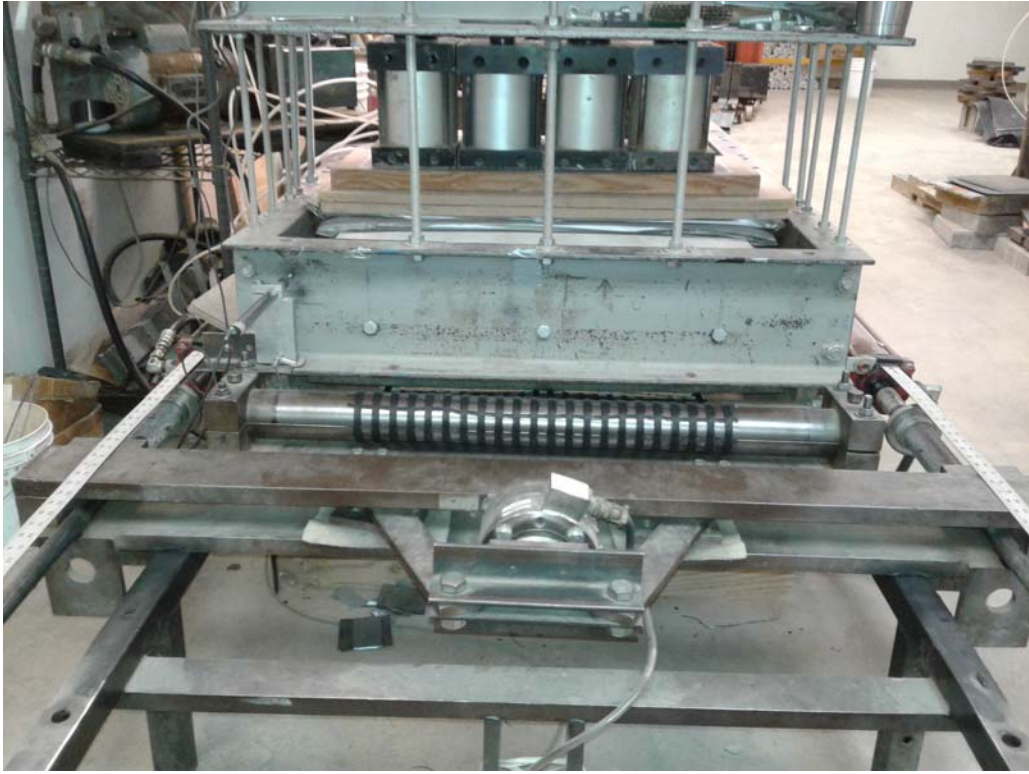
Figure A-3. Front view of the connection test setup.

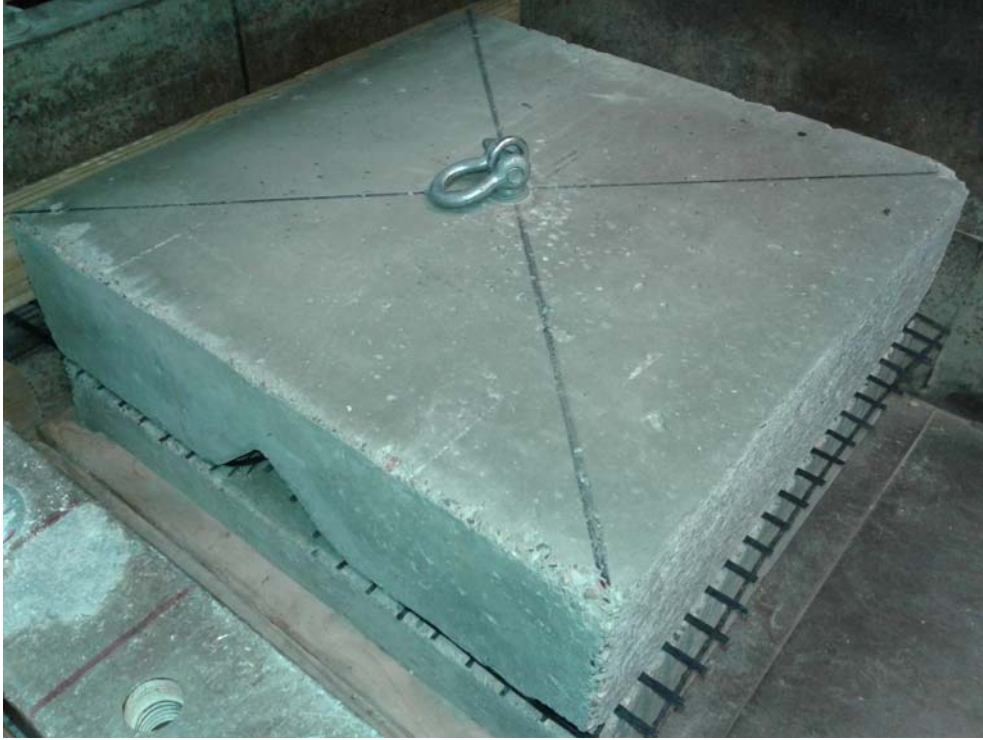
Figure A-4. A geogrid placed between bottom and top V-Interlock blocks.

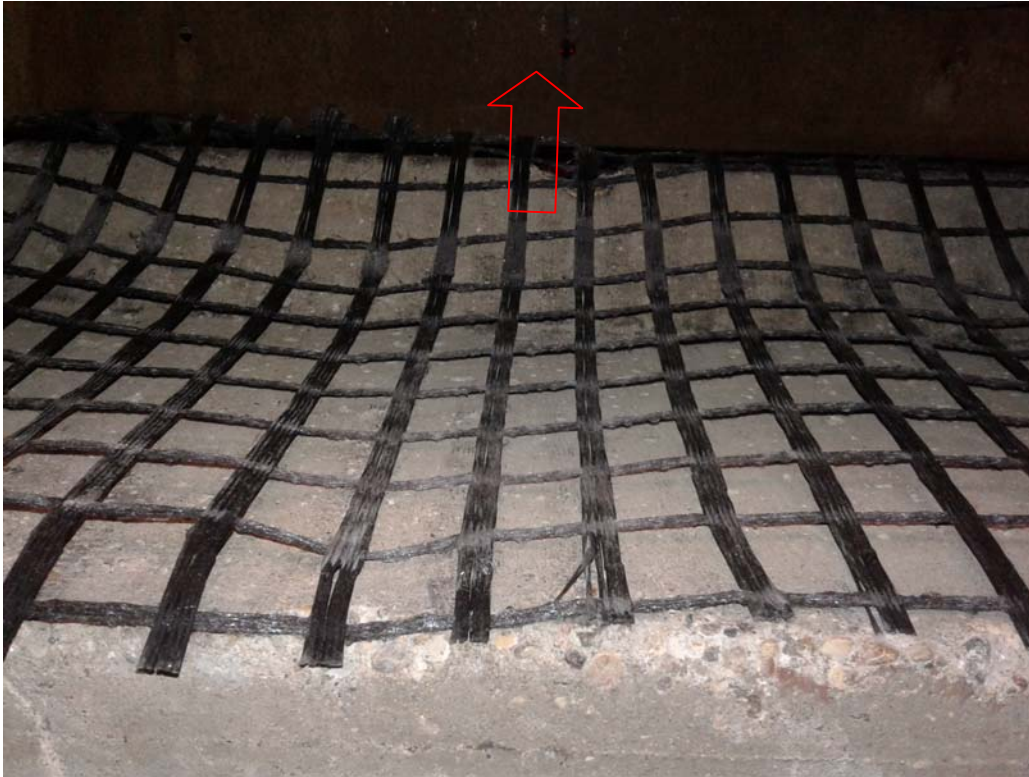
Figure A-5. Abrasion and rupture of geogrid at the completion of a test. The arrow points to direction of connection load.

Abrasion and/or rupture of geogrid ribs against the V-shaped shear key of blocks in each test.

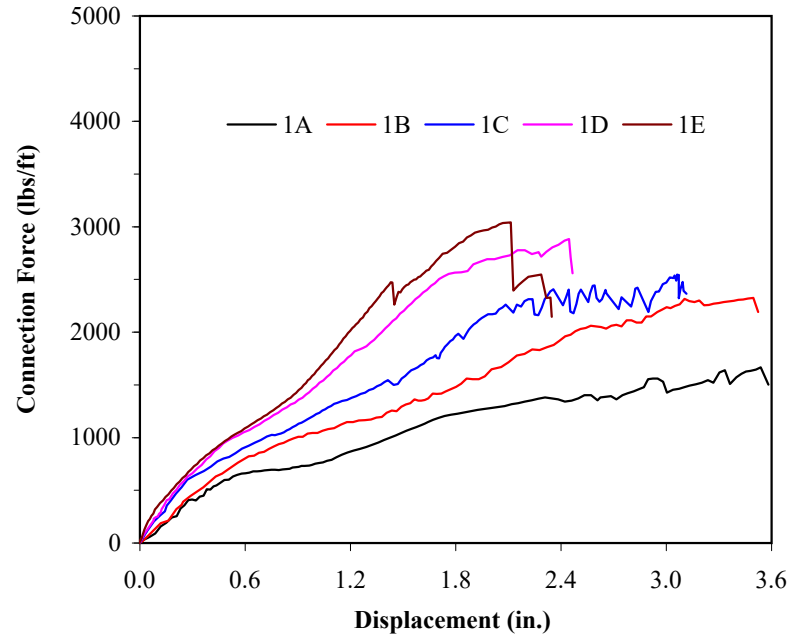
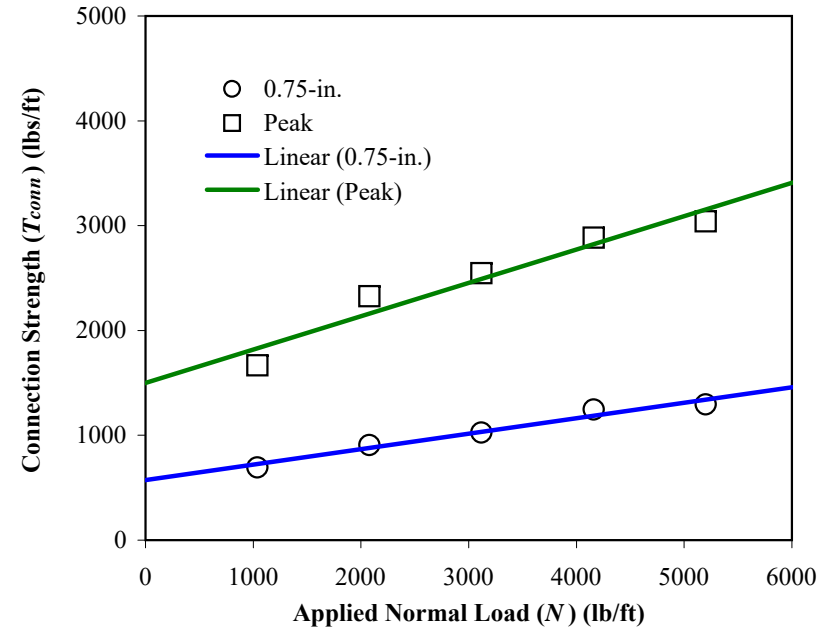
FIGURE NO. B-1

SRW PRODUCTS CONNECTION STRENGTH TESTING (ASTM D 6638)

TEST SERIES NO. 1: SRW-7 geogrid in machine direction between two courses of V-Interlock blocks
without AASHTO #57 stone

Test No.	Geogrid Specimen Width W (in.)	Test Normal Stress σ_n (psi)	Equivalent Normal Load N (lb/ft)	Approximate No. of Blocks n (-)	Approximate Wall Height h (ft)	0.75-in. Strength $I_{0.75-in}$ (lb/ft)	Peak Strength I_{peak} (lb/ft)	Connection Strength Equations (Strength assumed to be linearly related to N)
1A	23.0	3.6	1040			694	1665	$T_{0.75-in.} = 570 + (N) \tan (8^\circ)$ $T_{peak} = 1500 + (N) \tan (18^\circ)$
1B	23.0	7.2	2080			906	2325	
1C	23.0	10.8	3120			1026	2547	
1D	23.0	14.4	4160			1244	2885	
1E	23.0	18.1	5200			1293	3041

Dimensions of Block: 24" wide by 24" long and 6" high.

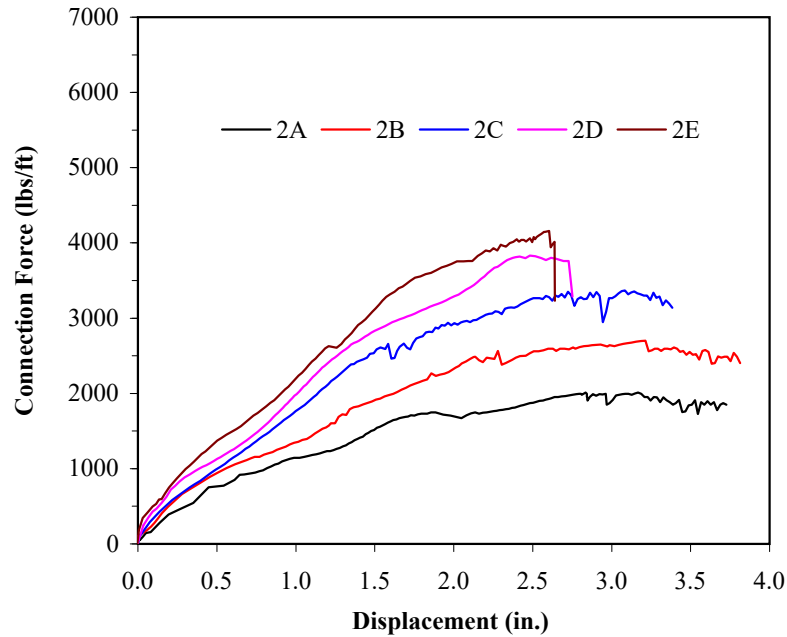
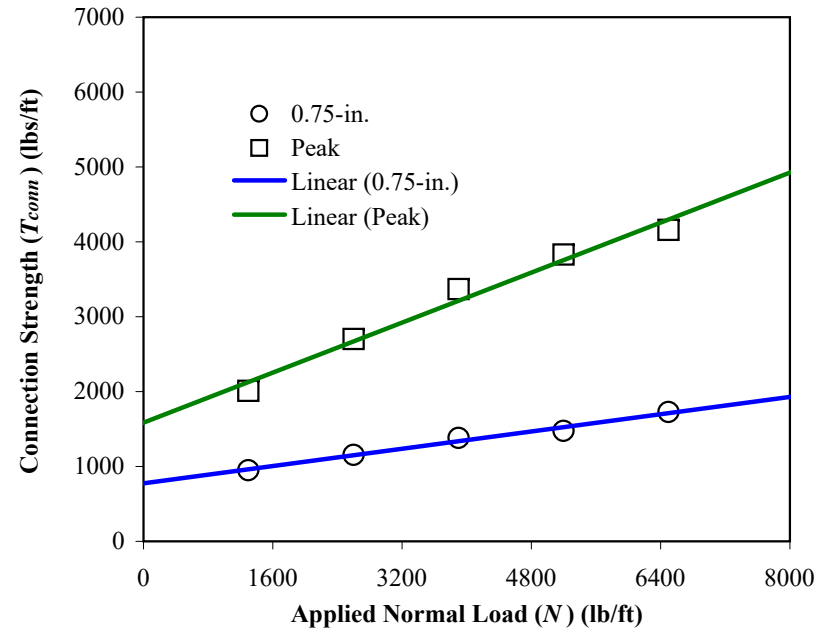
FIGURE NO. B-2

SRW PRODUCTS
CONNECTION STRENGTH TESTING (ASTM D 6638)

TEST SERIES NO. 2: SRW-9 geogrid in machine direction between two courses of V-Interlock blocks
 without AASHTO #57 stone

Test No.	Geogrid Specimen Width W (in.)	Test Normal Stress σ_n (psi)	Equivalent Normal Load N (lb/ft)	Approximate No. of Blocks n (-)	Approximate Wall Height h (ft)	0.75-in. Strength $T_{0.75-in}$ (lb/ft)	Peak Strength T_{peak} (lb/ft)	Connection Strength Equations (Strength assumed to be linearly related to N)
2A	23.0	4.5	1300			950	2010	$T_{0.75-in.} = 775 + (N) \tan (8 ^\circ)$ $T_{peak} = 1585 + (N) \tan (23 ^\circ)$
2B	23.0	9.0	2600			1153	2699	
2C	23.0	13.5	3900			1380	3369	
2D	23.0	18.1	5200			1475	3831	
2E	23.0	22.6	6500			1727	4160

24" wide by 24" long and 6" high.

Abrasion and/or rupture of geogrid ribs against the V-shaped shear key of blocks in each test.

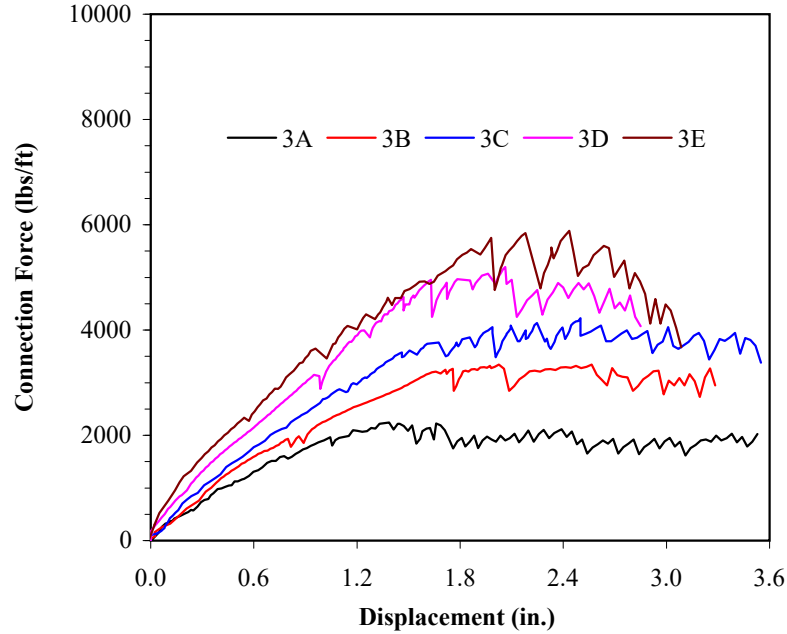
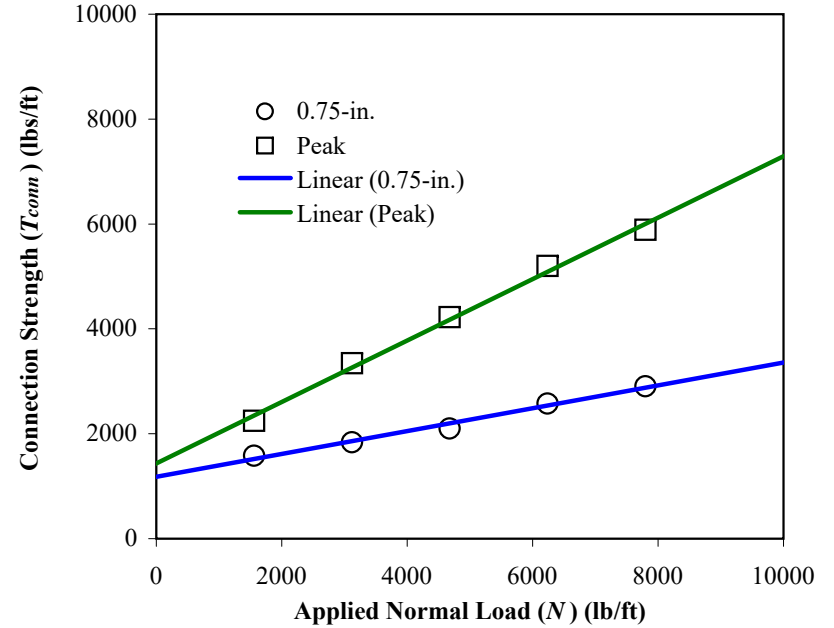
FIGURE NO. B-3

**SRW PRODUCTS
CONNECTION STRENGTH TESTING (ASTM D 6638)**

TEST SERIES NO. 3: SRW-11 geogrid in machine direction between two courses of V-Interlock blocks
without AASHTO #57 stone

Test No.	Geogrid Specimen Width W (in.)	Test Normal Stress σ_n (psi)	Equivalent Normal Load N (lb/ft)	Approximate No. of Blocks n (-)	Approximate Wall Height h (ft)	0.75-in. Strength $T_{0.75-in}$ (lb/ft)	Peak Strength T_{peak} (lb/ft)	Connection Strength Equations (Strength assumed to be linearly related to N)
3A	23.0	5.4	1560			1579	2243	$T_{0.75-in.} = 1180 + (N) \tan (12^\circ)$ $T_{peak} = 1435 + (N) \tan (30^\circ)$
3B	23.0	10.8	3120			1836	3342	
3C	23.0	16.3	4680			2099	4223	
3D	23.0	21.7	6240			2574	5197	
3E	23.0	27.1	7800			2906	5885

24" wide by 24" long and 6" high.

Abrasion and/or rupture of geogrid ribs against the V-shaped shear key of blocks in each test.
